ADDENDUM II

- 1.) Crime Application general information
- 2.) Lake Casa Blanca Dam Inspection Report
- 3.) Claims history Oct 2011 thru July 2017

TX02267- Lake Casa Blanca Dam

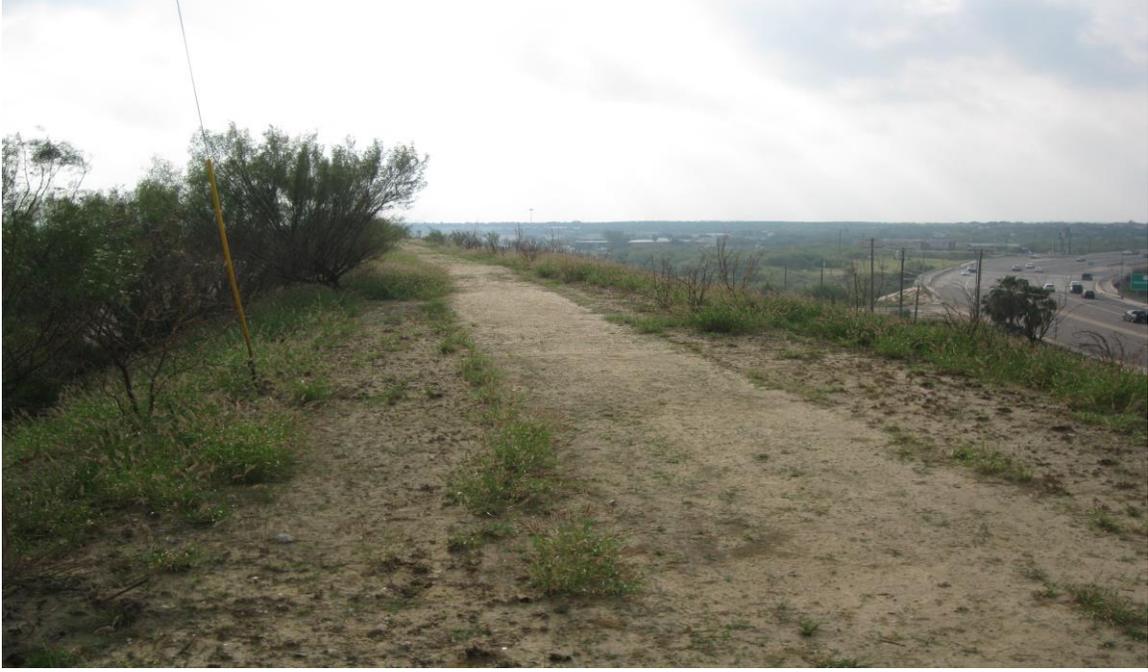
- The crest had an approximate length of 5800 feet and a crest width of 15 feet.
- Vegetation was noted along shoulders of the crest consisting of brush, grass and small trees (Photo 1 & 2).
- A small number of sinkholes were found on the crest ranging from 6 to 12 inches deep (Photo 3).
- A number of erosion rills and paths (from human traffic) were noted to cut into the crest from both the downstream and upstream slope (Photo 4).
- The crest was found to be in fair condition.

Photo 1. View of the crest path looking left. Note the grass, brush and trees encroaching on the edges of the crest path.

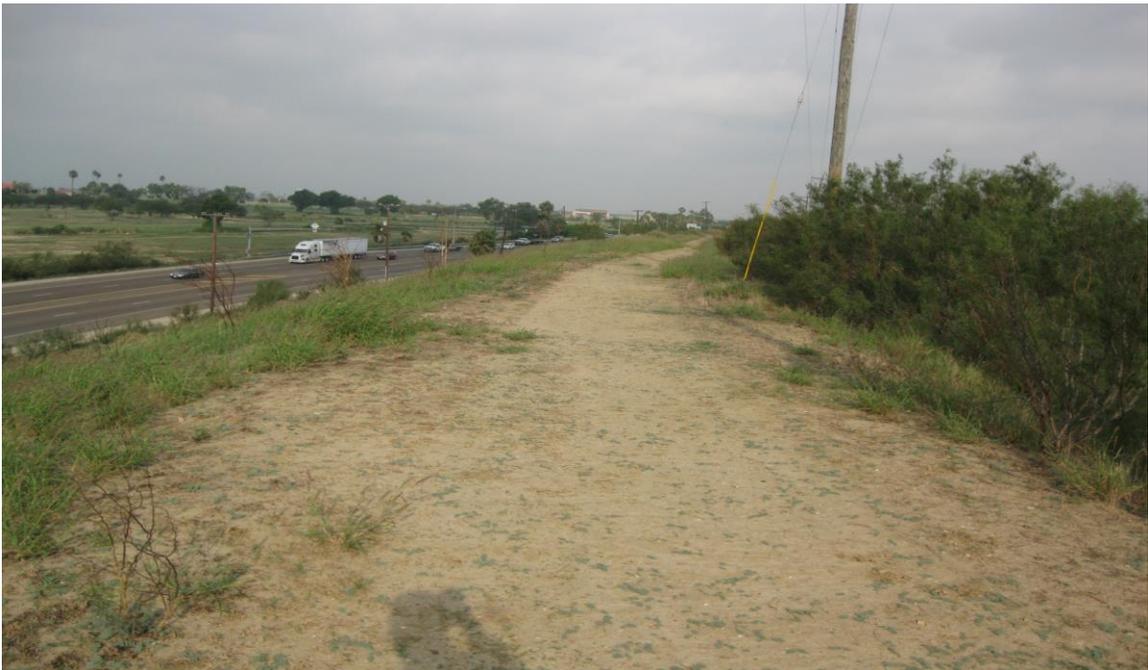
Photo 2. Reverse view of photo 1 on crest path looking right.

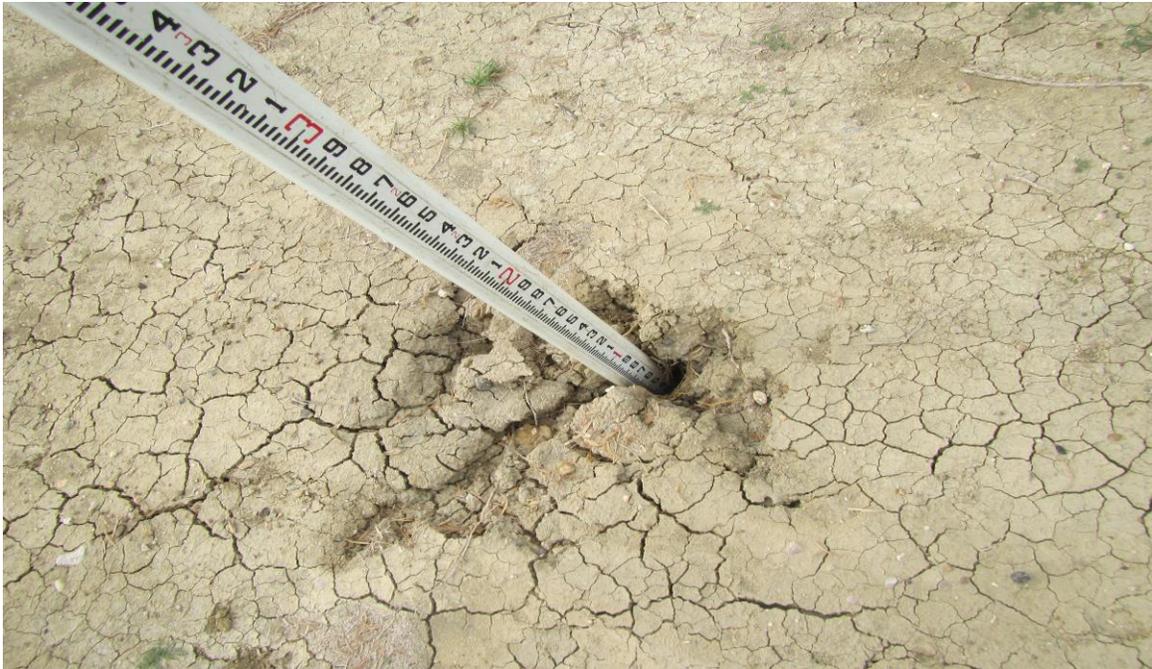
Photo 3. One of several sinkholes found on the crest.

9. Sinkholes on the crest should be backfilled in order to prevent water seeping into the dam structure.
10. Waterlines and sprinkler heads intended for watering on the downstream slope should be monitored for any leakage.

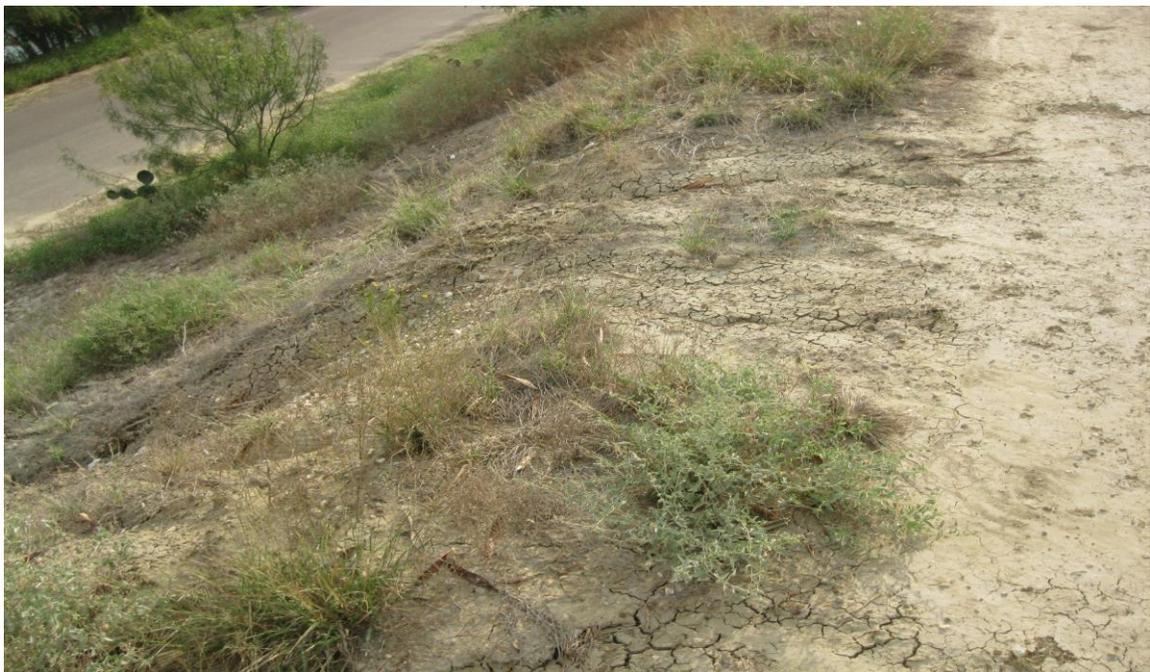
Photo 4. Erosion initiated at the crest edge into the upstream slope.

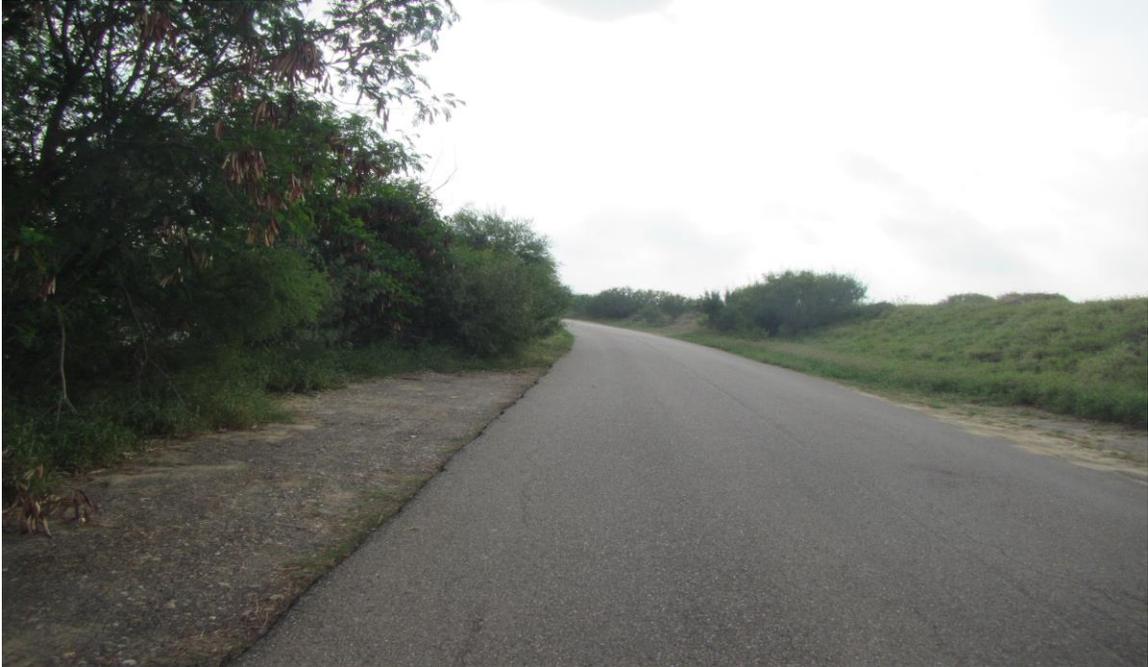
Photo 5. View of the upstream looking left and its three sections: (From left to right) the lower portion near the water line, the roadway/berm, and the upper portion near the crest.

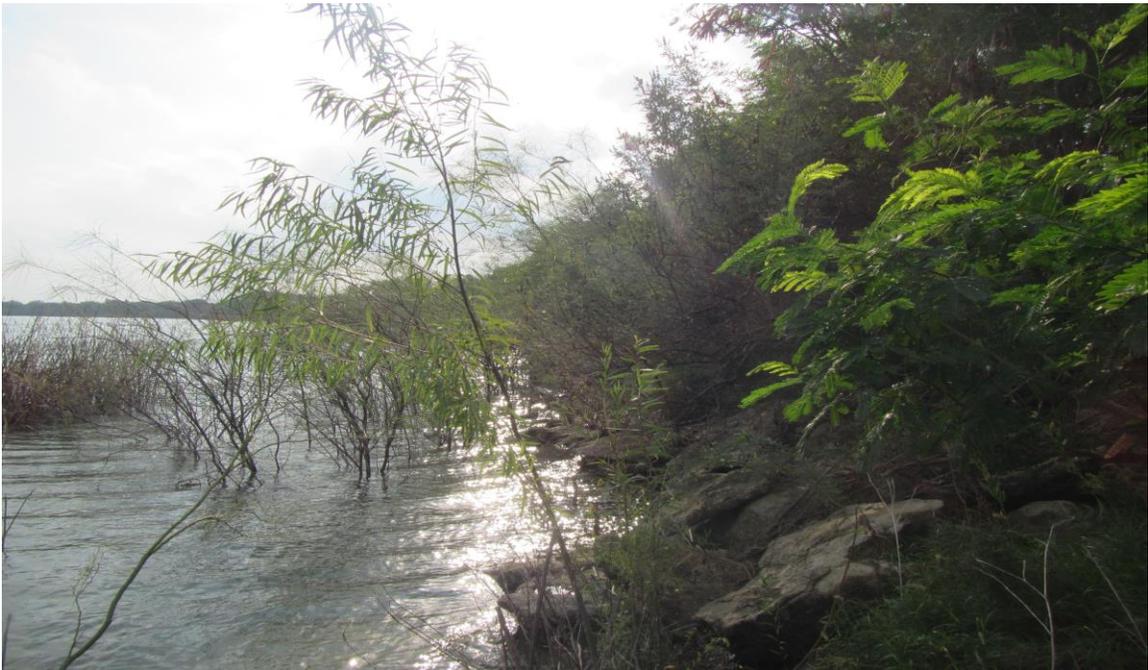
- Recycled concrete rip rap, placed in a random and non-uniform manner, was located on the lower section downstream slope (Photo 6 & 7).
- Benching was noted along the lower section of the upstream slope, creating steep slopes with some areas of exposed tree root systems (Photo 8).

Photo 6. View of a typical section of the lower portion of the upstream slope looking left. Note the heavy tree growth, large rock and concrete riprap.

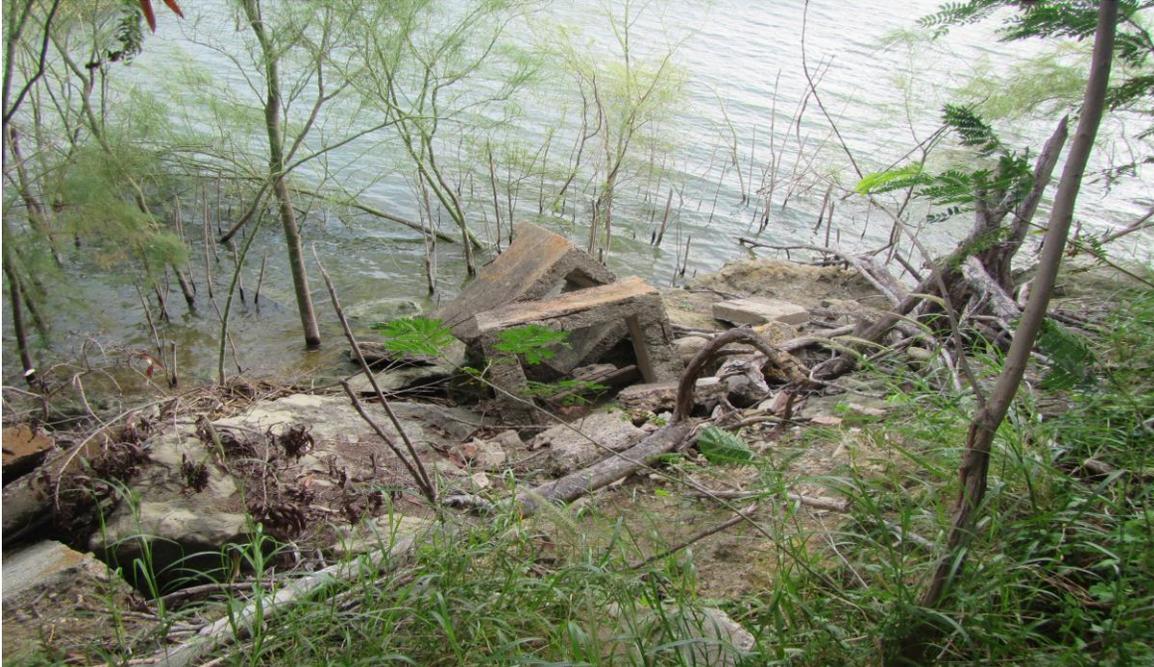
Photo 7. Photo of recycled concrete rip rap used to stabilize lower portion of upstream slope from wave action benching.

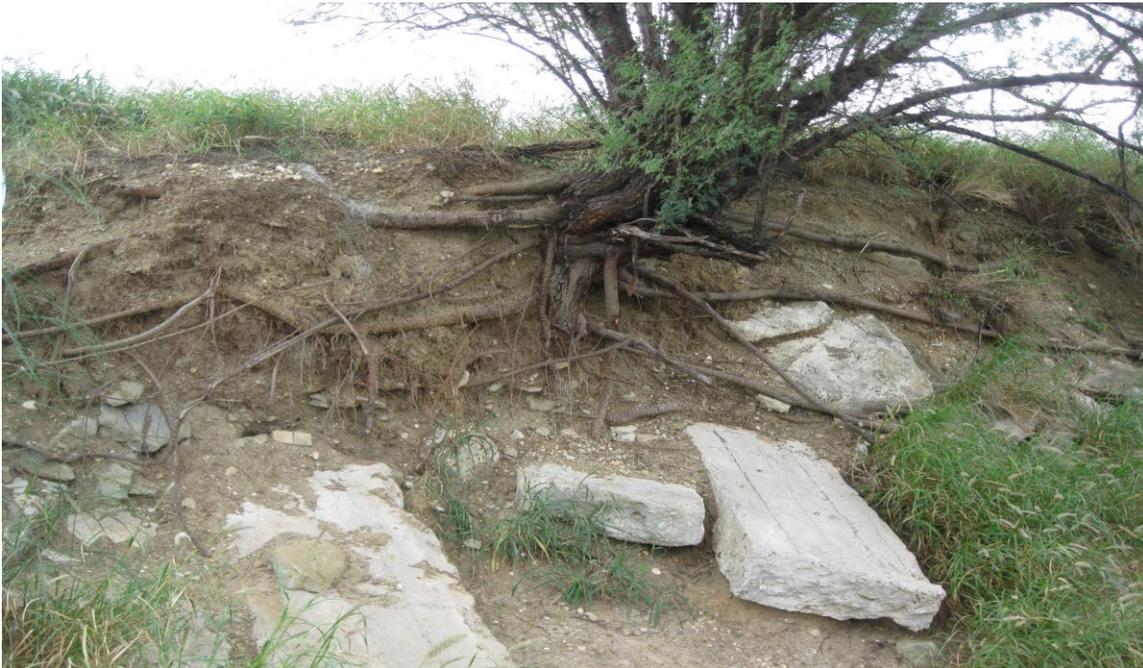
Photo 8. Photo of lower portion of upstream slope where wave action has eroded the embankment. Note the exposure of the tree root system.

6. The lower section of the upstream slope (near the waterline) should be inspected by a LTPE to determined severity of benching, slides and trails (initiated by human traffic). Repairs/stabilization should be performed under the supervision of a LTPE.

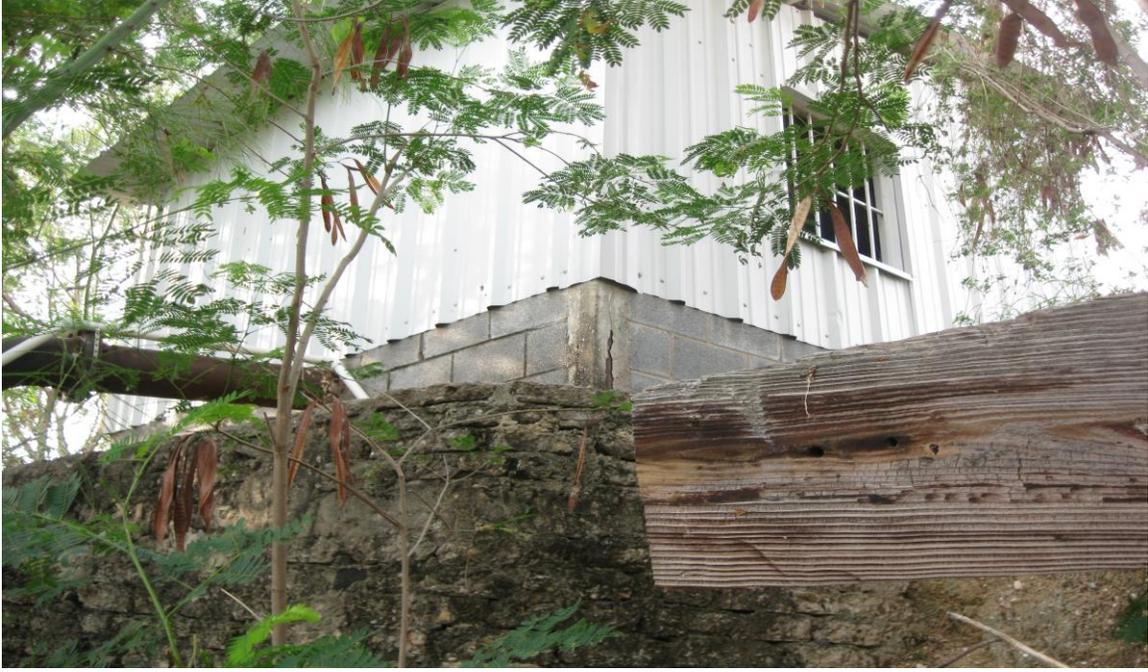
- A pump house was built on the slope near the right portion of the dam. It is believed that the pump house was previously used to pump water to the golf course across the Bob Bollock Parkway from the dam. The pump house foundation was noted to have gaps within the embankment material (Photo 9 & 10).

Photo 9. View of old pump house on the lower portion of upstream slope.

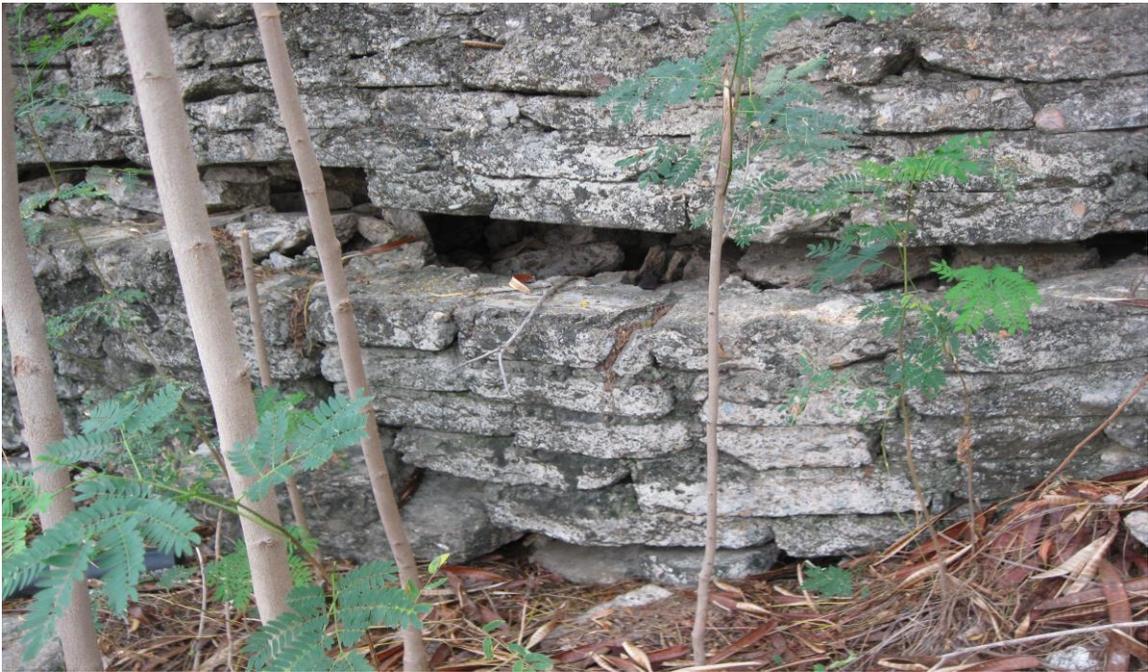
Photo 10. Photo of old pump house foundation, note the gap from erosion of embankment material.

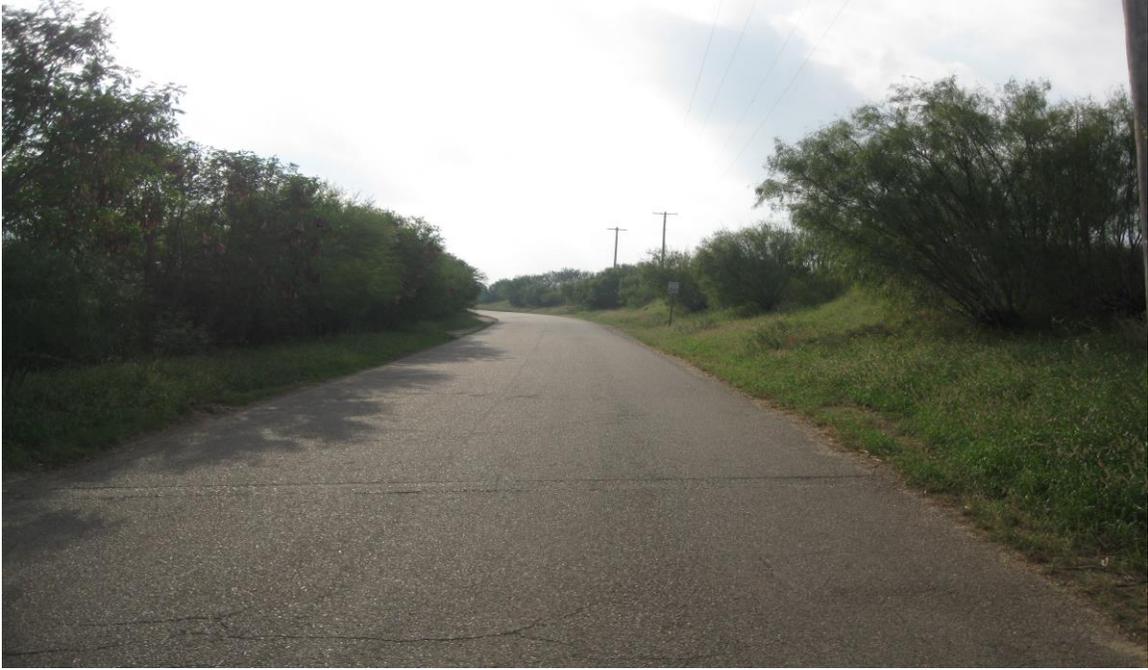
- Large and small trees were noted along the lower section of the downstream slope (Photo 11).
- The roadway/berm appeared to be in fair condition with some alligator cracking (Photo 11).

Photo 11. View of roadway/berm looking left, found to be in good condition. Note the trees located on the lower and upper sections of the upstream slope.

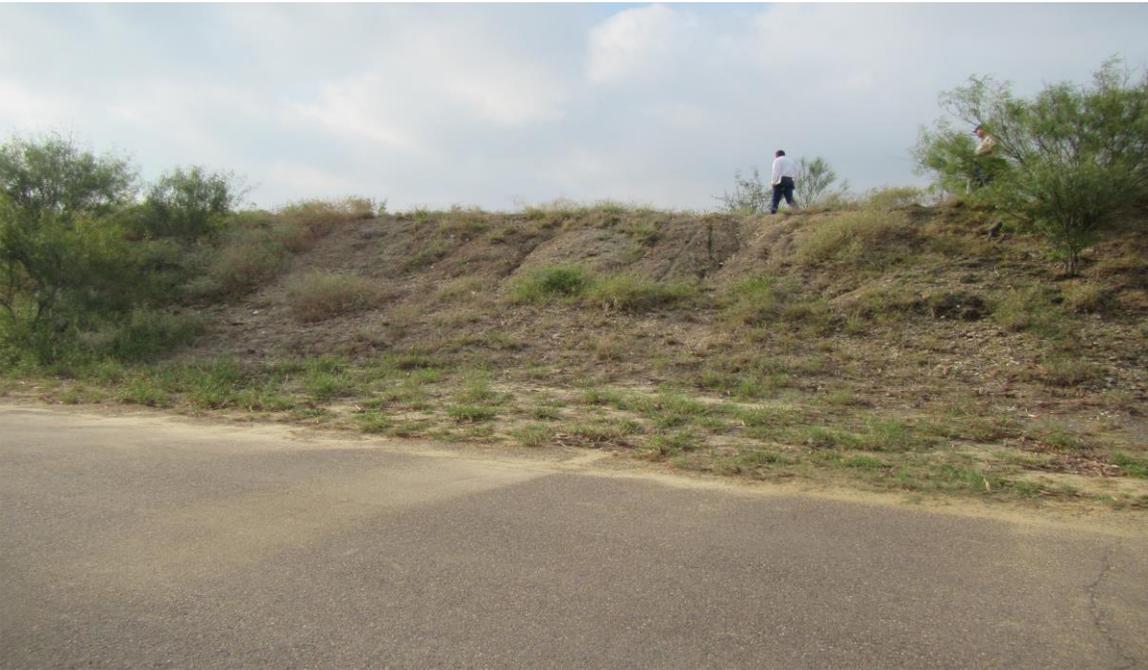
- Large and small trees were noted along the upper section of the upstream slope along with decent grass coverage.
- Erosion rills were noted along the upper section, along with erosion caused by human traffic (Photo 12).
- The upstream slope was found to be in fair condition.

Photo 12. One of several erosion rills found on upper portion of upstream slope.

4. Erosion gullies located predominately on the downstream slope and upstream slope areas should be repaired/stabilized under the supervision of a Licensed Texas Professional Engineer (LTPE).

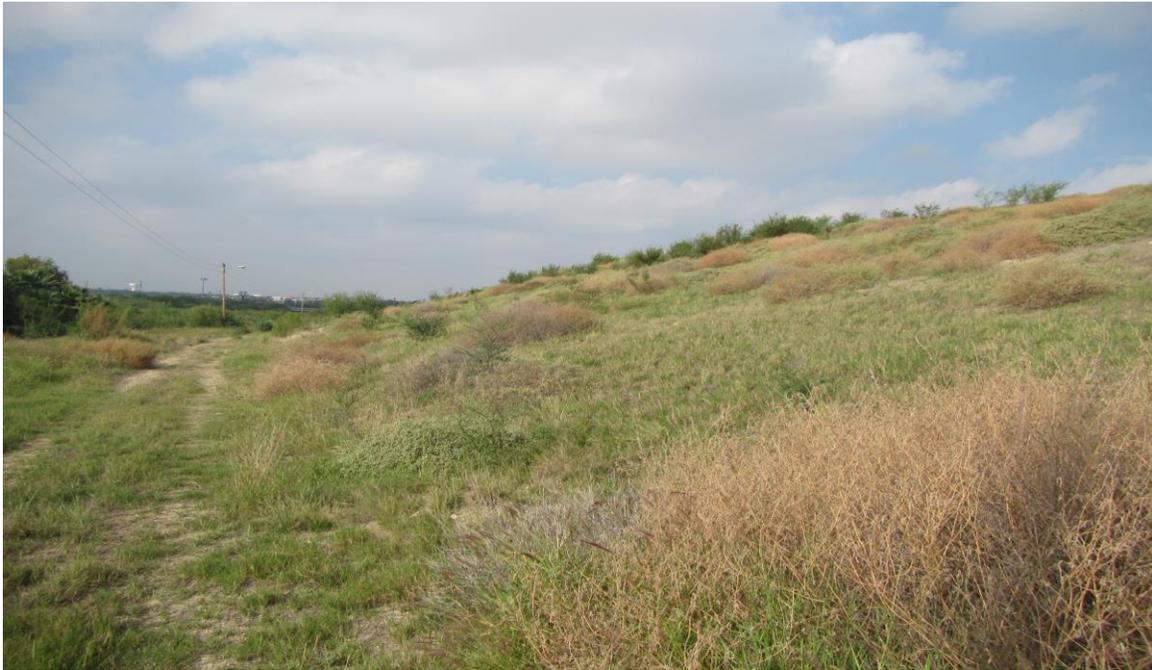
Photo 13. View of downstream slope looking right. Note the fair grass coverage and brush growth.

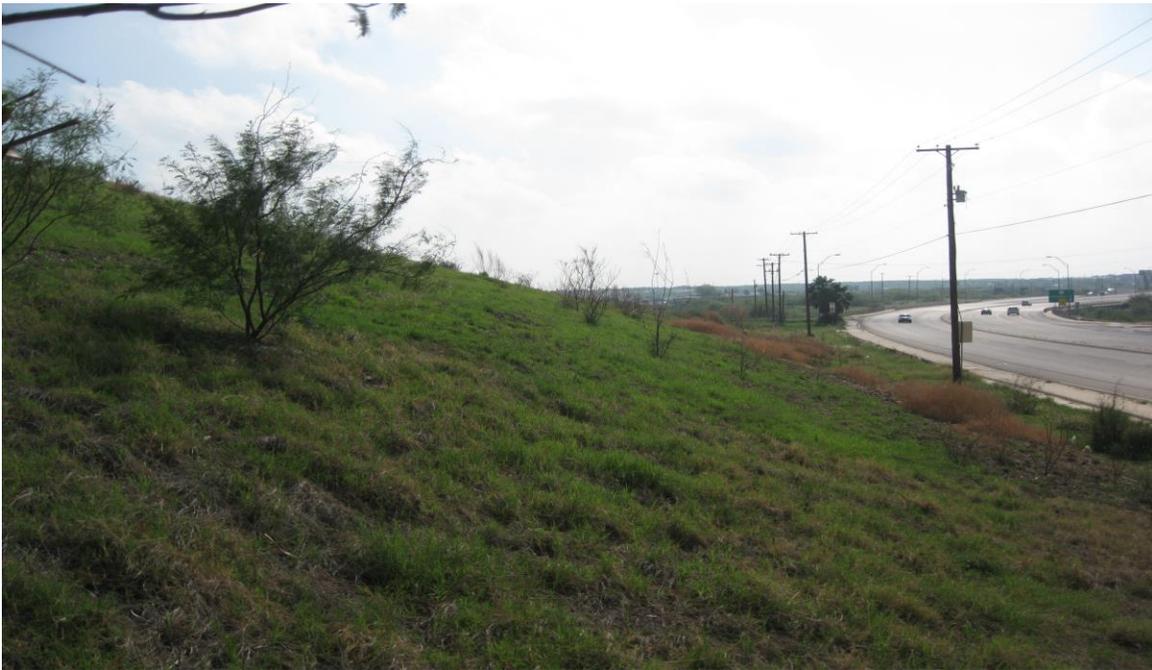
Photo 14. Additional view of downstream slope and the Bob Bullock freeway looking left. Note the good grass coverage, brush and young tree growth.

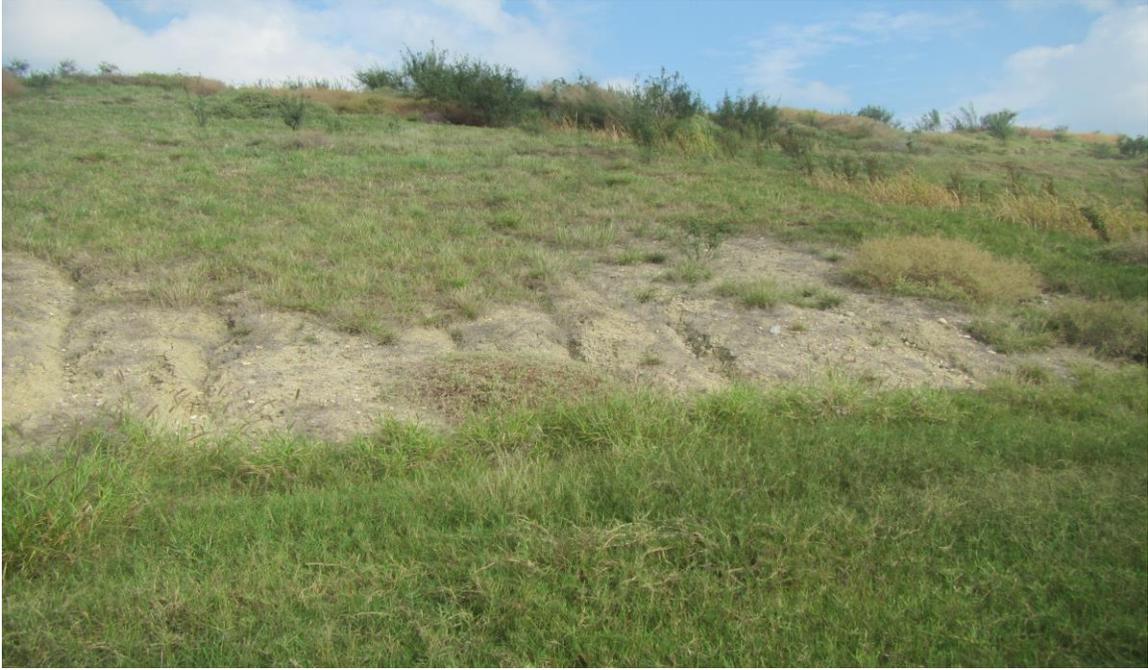
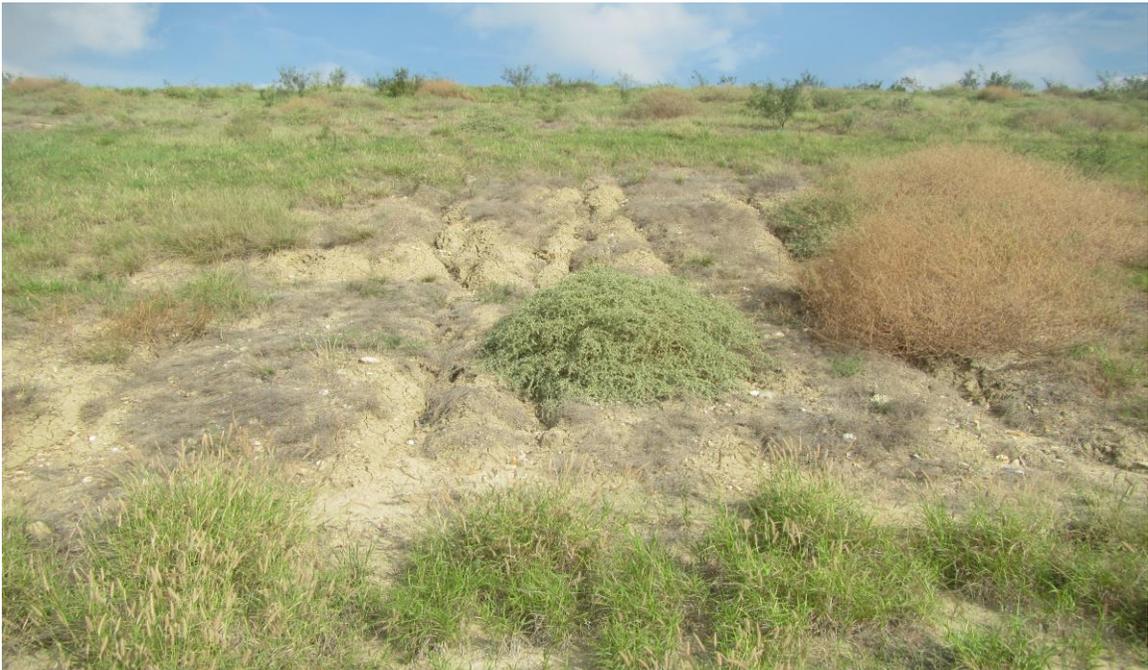
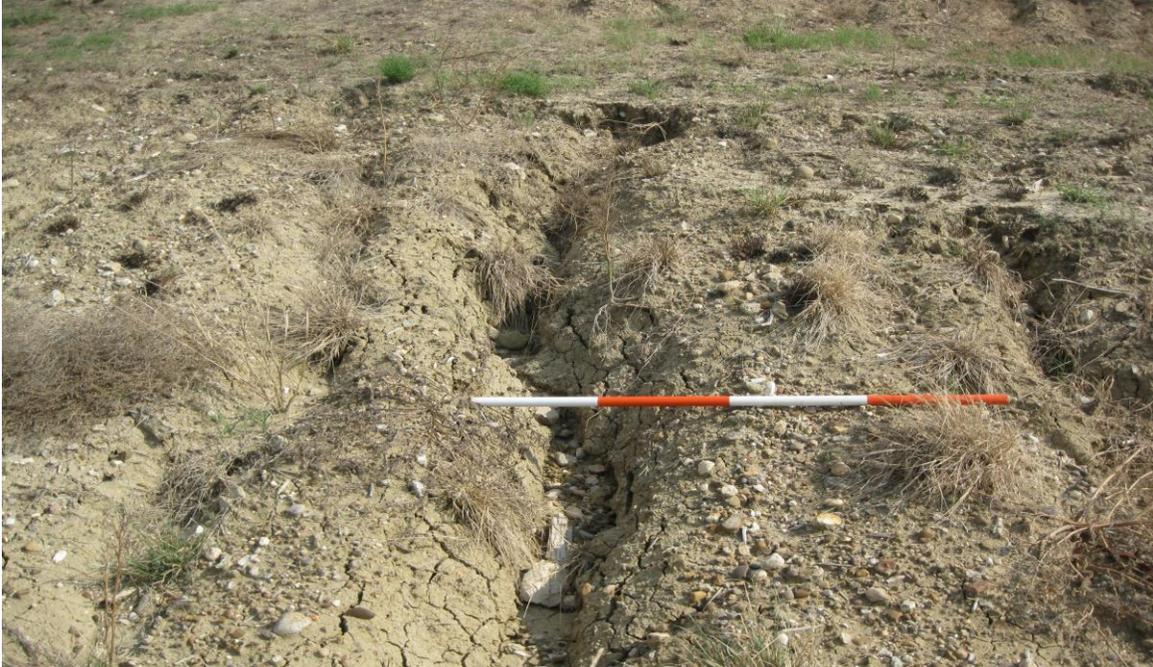
Photo 15. One of many erosion rills found throughout the downstream slope.

Photo 16. Additional photo of rills gullies found throughout the downstream slope.

Photo 17. Additional photo of erosion rills found throughout the downstream slope.

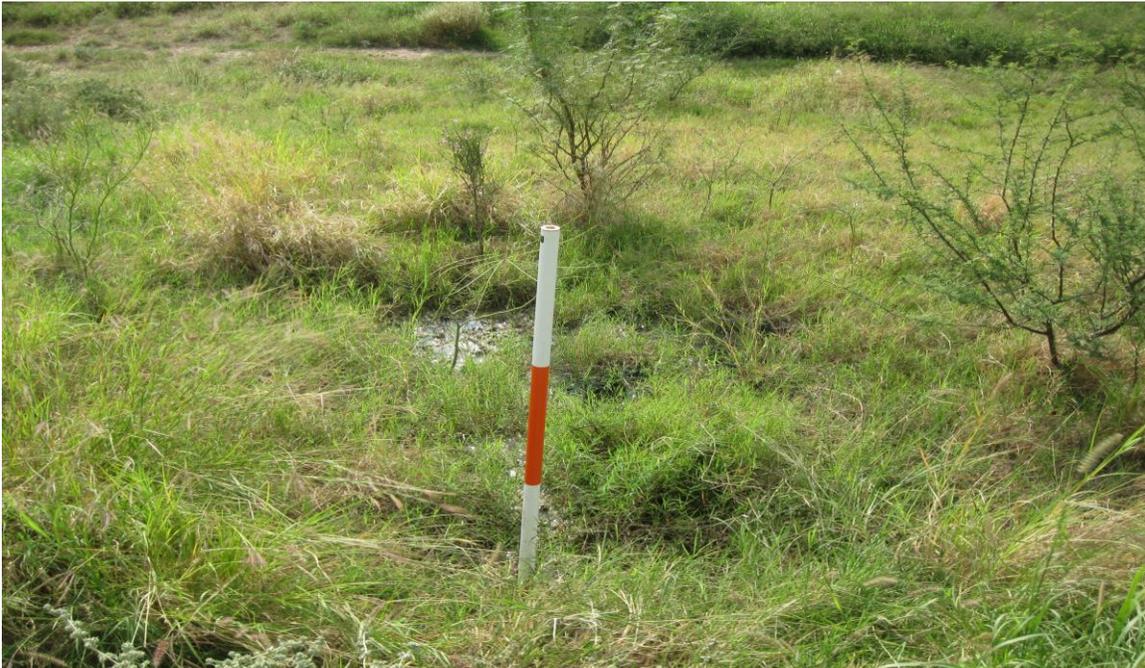
- Wetness was located on the left end of the slope, found on the lower 1/3 portion. The wetness was later determined to be caused from a broken 2 inch water line placed by the City of Laredo. An email sent from Mr. Santos on 11/6/2015, stated the water line would be repaired. A number of water lines and sprinkler heads were also found along the slope. They were installed during the 2012 improvements with the intent of irrigating the slope to facilitate vegetation establishment (Photo 18).

Photo 18. Photo of seepage found on downstream slope from a broken waterline. Seepage was located on the eastern side of the slope, found on the lower 1/3 portion.

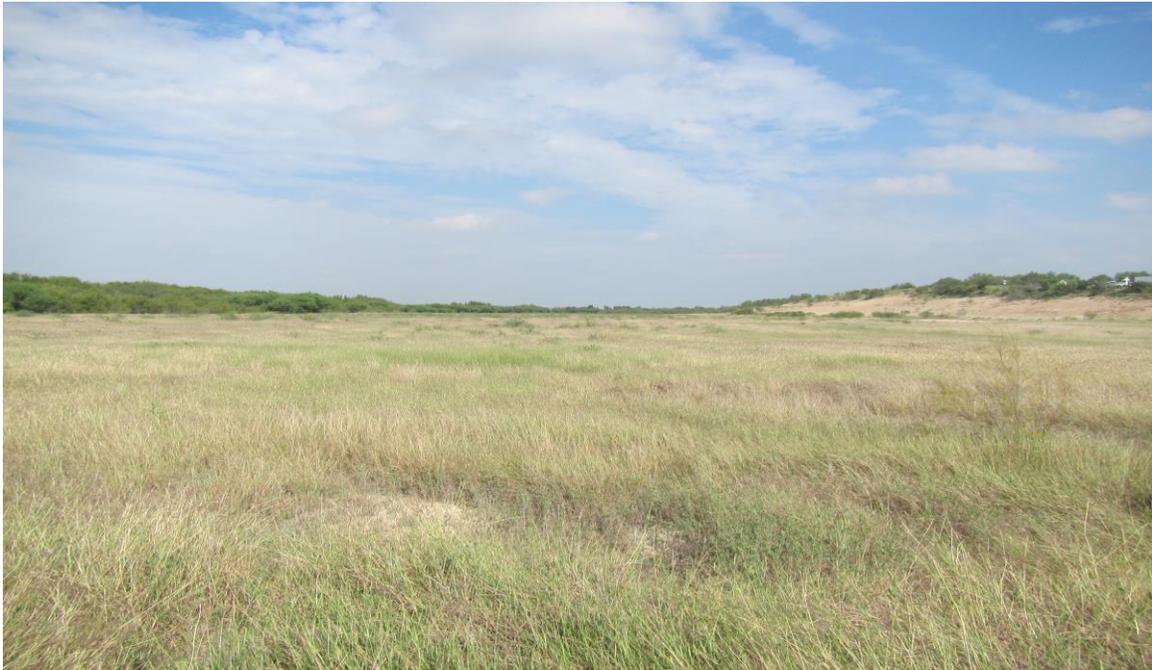
Photo 19. View of service spillway located to the left of the dam, looking north. Note the good grass coverage.

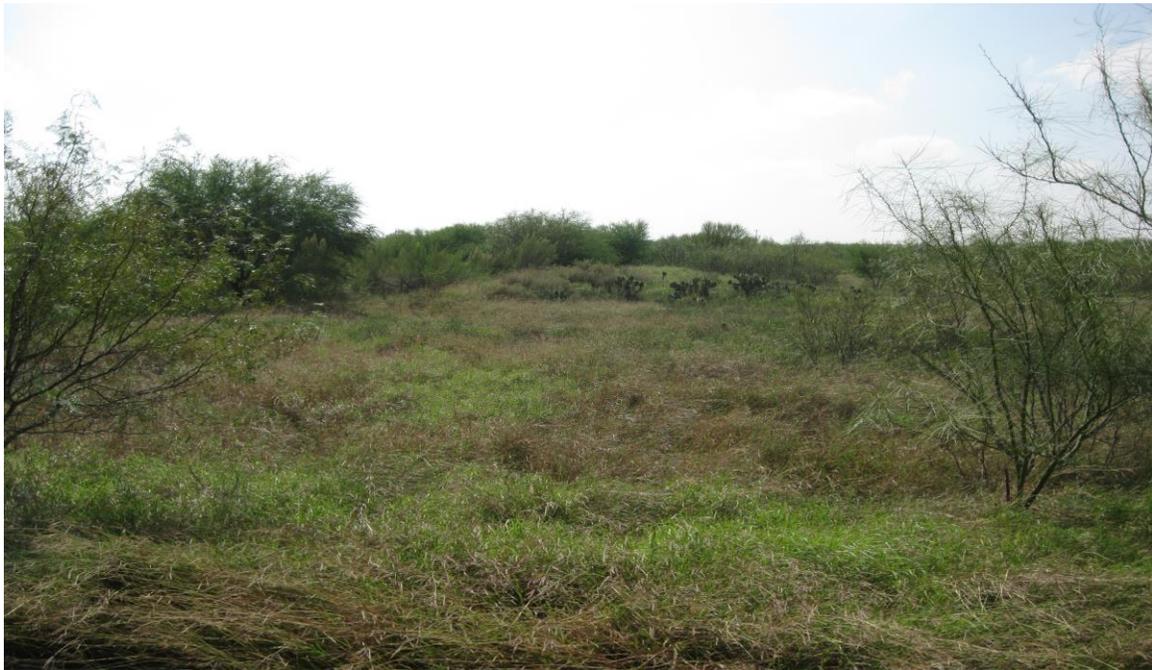
- A small mound that appeared to be from dumped material was located southeast of the access road. This may impede the flow of water when the spillway is engaged (Photo 20).
- The service spillway was found to be in fair condition.

Photo 20. View of service spillway looking south. Note the small mound and vegetation.

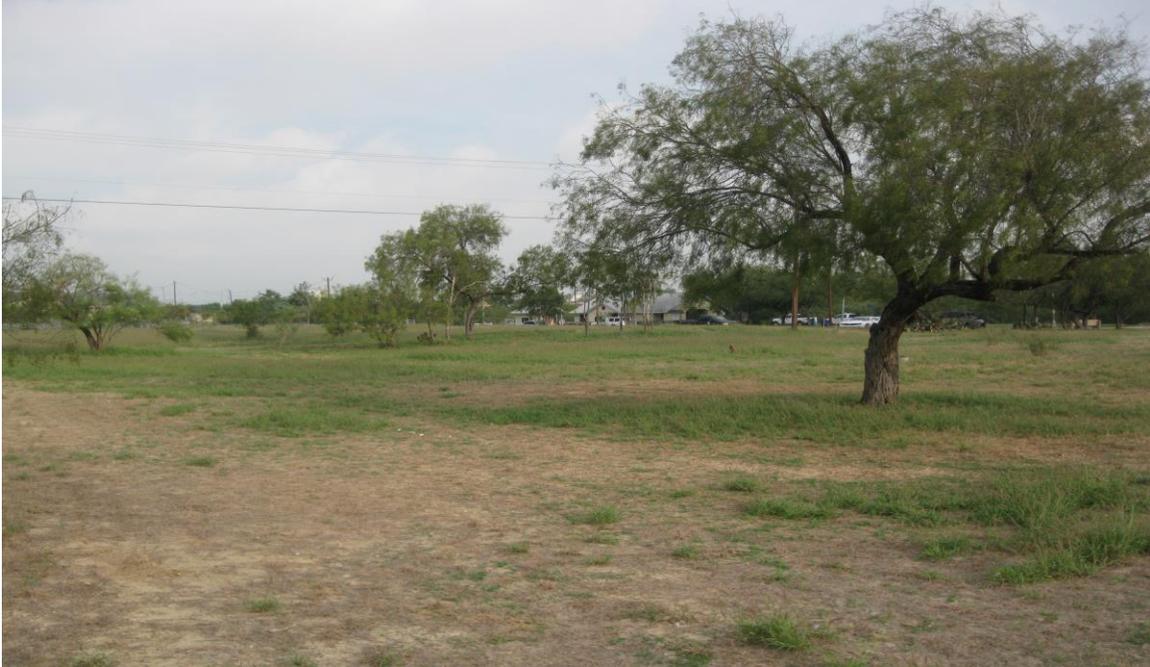
- The emergency spillway is located near the park entrance, and consists of a wide flat area with several buildings and parking lots (Photo 21).
- Flows in the emergency spillway would discharge directly onto Bob Bullock Loop 20.
- The emergency spillway was found to be in fair condition.

Photo 21. View of emergency spillway near entrance of the park.

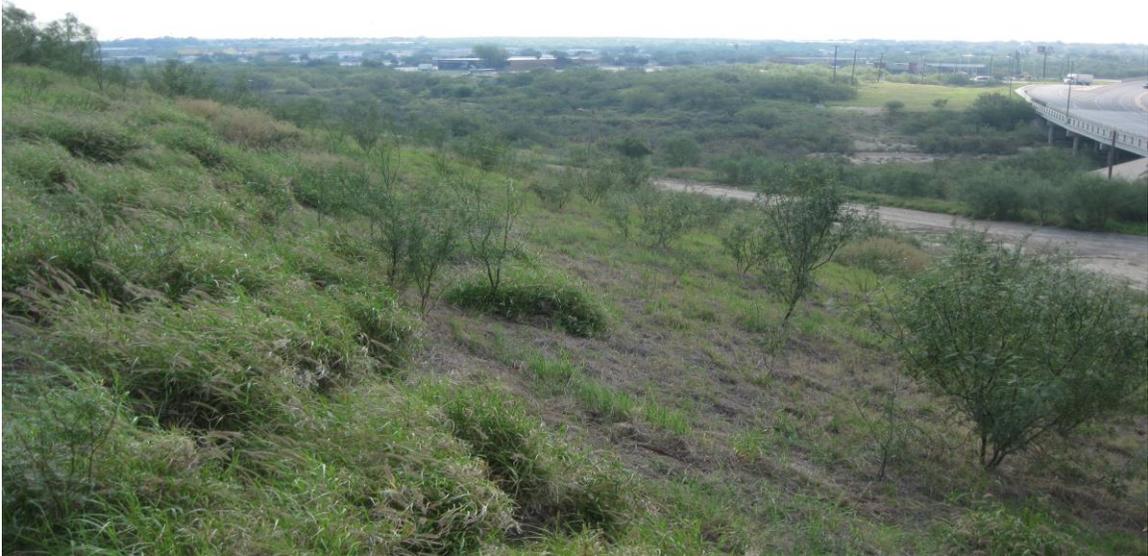
Figure 2 shows Chacon Creek and its flow line as it passes under Bob Bullock Loop 20 (Photo 22 & 23). The service spillway empties into Chacon Creek, flows under Bob Bullock Loop 20, and eventually empties into the Rio Grande approximately 3.6 miles downstream of the dam. Chacon creek runs parallel to the toe of the dam from left to right. The creek channel was overgrown with salt cedars and thick vegetation, which prevented a thorough inspection of the area downstream of the toe. It was noted that the channel bottom was wet and swampy. There was no flow observed at the left end of the dam, but as one progressed toward the Bob Bollock Bridge, a visible flow was observed in the creek channel. While no specific areas of flow emergence were seen, it is hypothesized that the flow in the creek channel was from combined seepage from the dam structure. The flow in the channel under the bridge was estimated to be 50 gpm.

Photo 22. View of Bob Bullock freeway (on the right), service spillway discharge will flow under freeway.

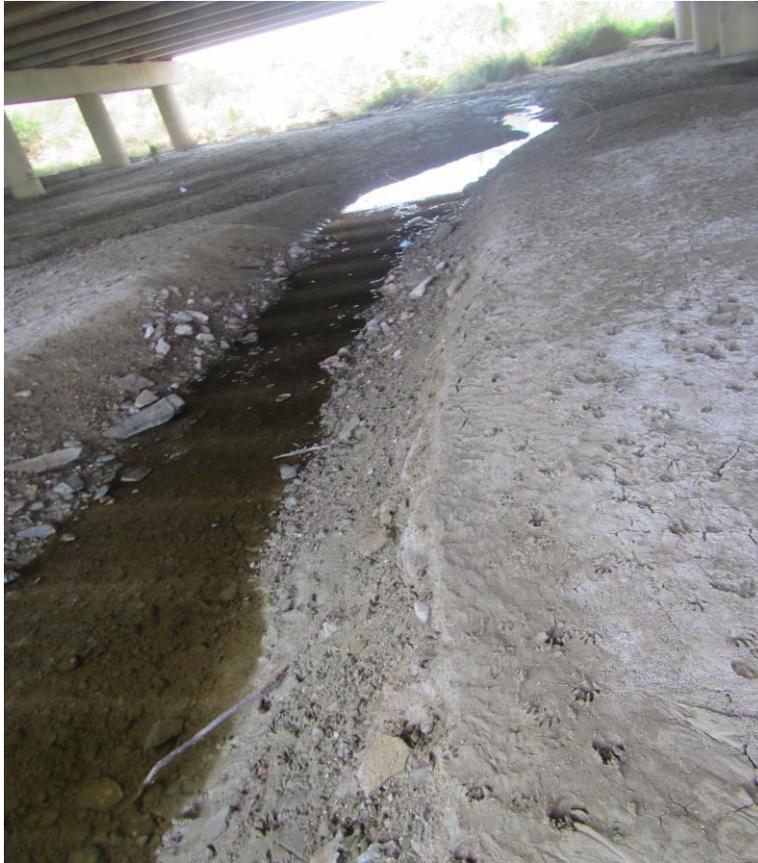
- The flow in Chacon Creek channel was estimated to be 50 gpm under the Bob Bullock Bridge. Given the relatively dry conditions prior to inspection, it is hypothesized that the flow observed at the Bob Bullock Bridge was comprised of the combined seepage from the dam structure.

Photo 23. Photo of downstream channel, Chacon Creek, under Bob Bullock freeway. Flow was estimated to be 50 gpm.

2. The Chacon Creek Channel downstream of the dam should be thoroughly inspected for specific points of flow emergence and/or boils. While no such areas were observed during this inspection, the combined flow of the bridge suggests heavily that seepage is occurring under the dam or foundation. The amount of seepage (estimated at 50 gpm) is not particularly alarming for a dam this size. However, if subsequent inspections determines that individual points of concentrated flow emergence in excess of 5 -10 gpm, then the dam should be monitored for possible piping conditions. Since the dam once suffered a piping failure and evidence of dispersive soils is present, it is important to monitor for any evidence of piping. Clearing of brush and trees from the Chacon Creek channel may be necessary to facilitate such routine inspections.

3. The combined channel flow at the Bob Bullock Bridge should be routinely monitored for increase in flow, particularly during dry periods when runoff in flows to the creek are minimal. Any significant increases beyond 50 gpm baseline may suggest an increase in seepage or development of a piping condition.
