ADDENDUM II

- 1.) Crime Application general information
- 2.) Lake Casa Blanca Dam Inspection Report
- 3.) Claims history Oct 2011 thru July 2017

TX02267- Lake Casa Blanca Dam

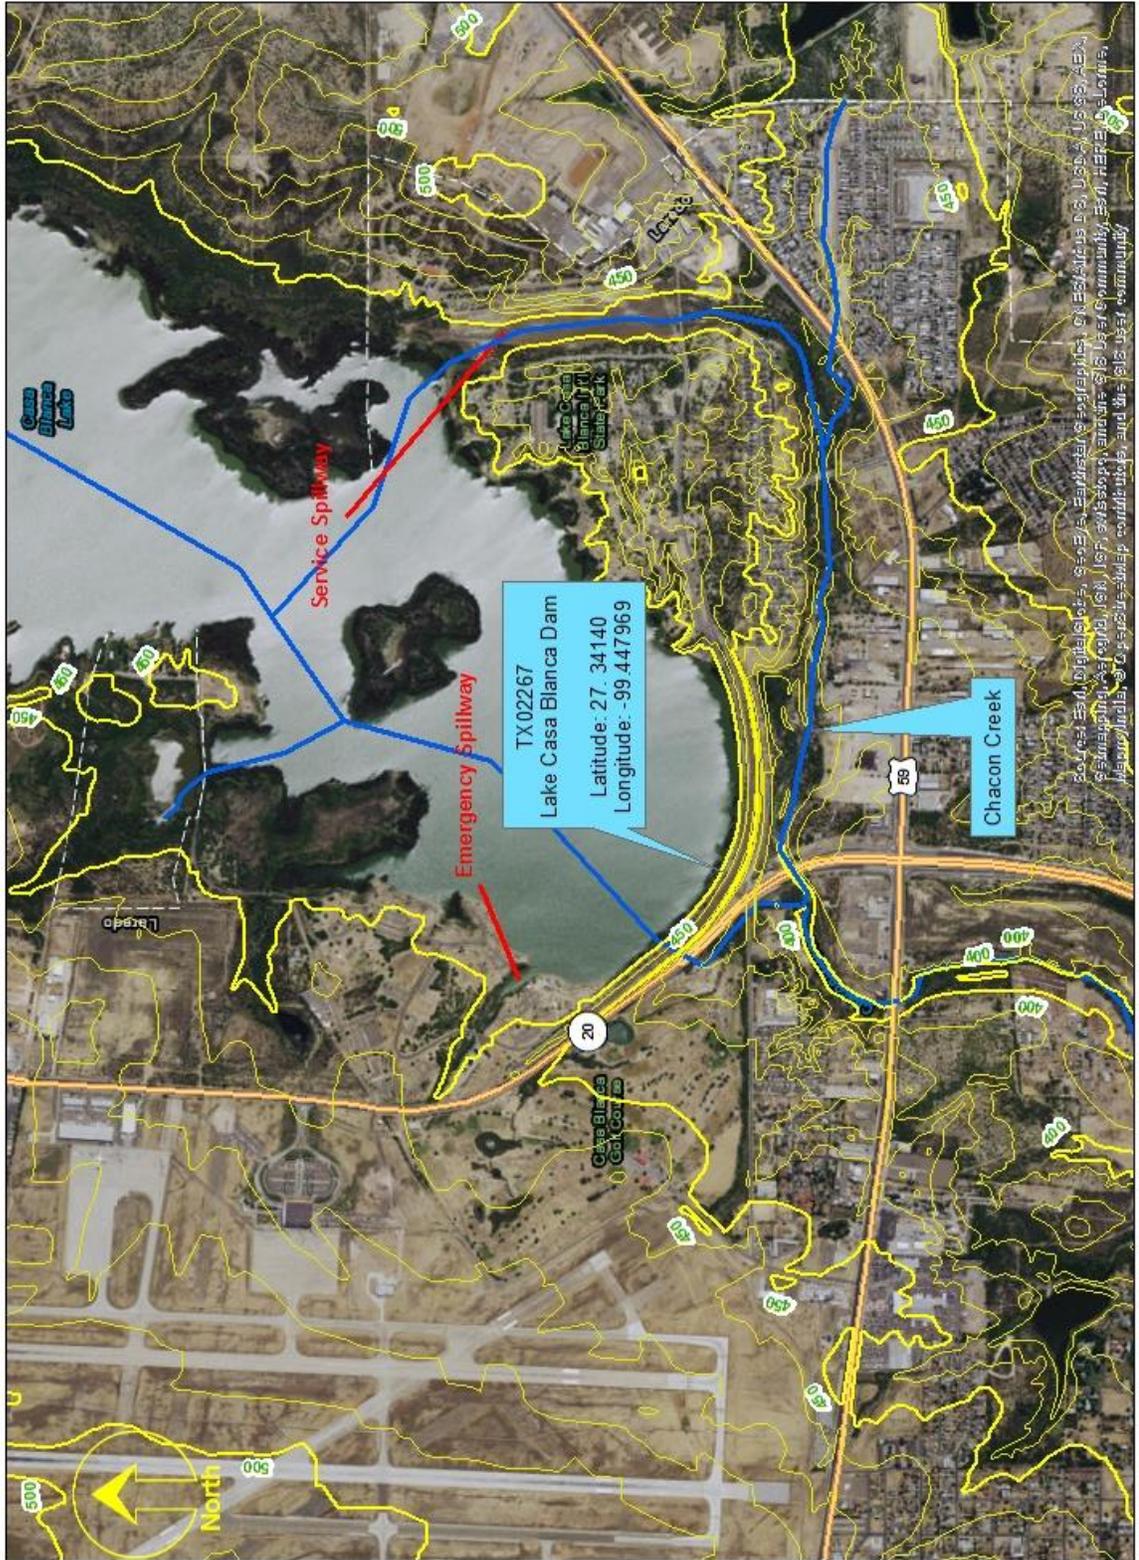
Figure 2 - Aerial Photo of Dam with Contours

Figure 2 shows Chacon Creek and its flow line as it passes under Bob Bullock Loop 20 (Photo 22 & 23). The service spillway empties into Chacon Creek, flows under Bob Bullock Loop 20, and eventually empties into the Rio Grande approximately 3.6 miles downstream of the dam. Chacon creek runs parallel to the toe of the dam from left to right. The creek channel was overgrown with salt cedars and thick vegetation, which prevented a thorough inspection of the area downstream of the toe. It was noted that the channel bottom was wet and swampy. There was no flow observed at the left end of the dam, but as one progressed toward the Bob Bollock Bridge, a visible flow was observed in the creek channel. While no specific areas of flow emergence were seen, it is hypothesized that the flow in the creek channel was from combined seepage from the dam structure. The flow in the channel under the bridge was estimated to be 50 gpm.

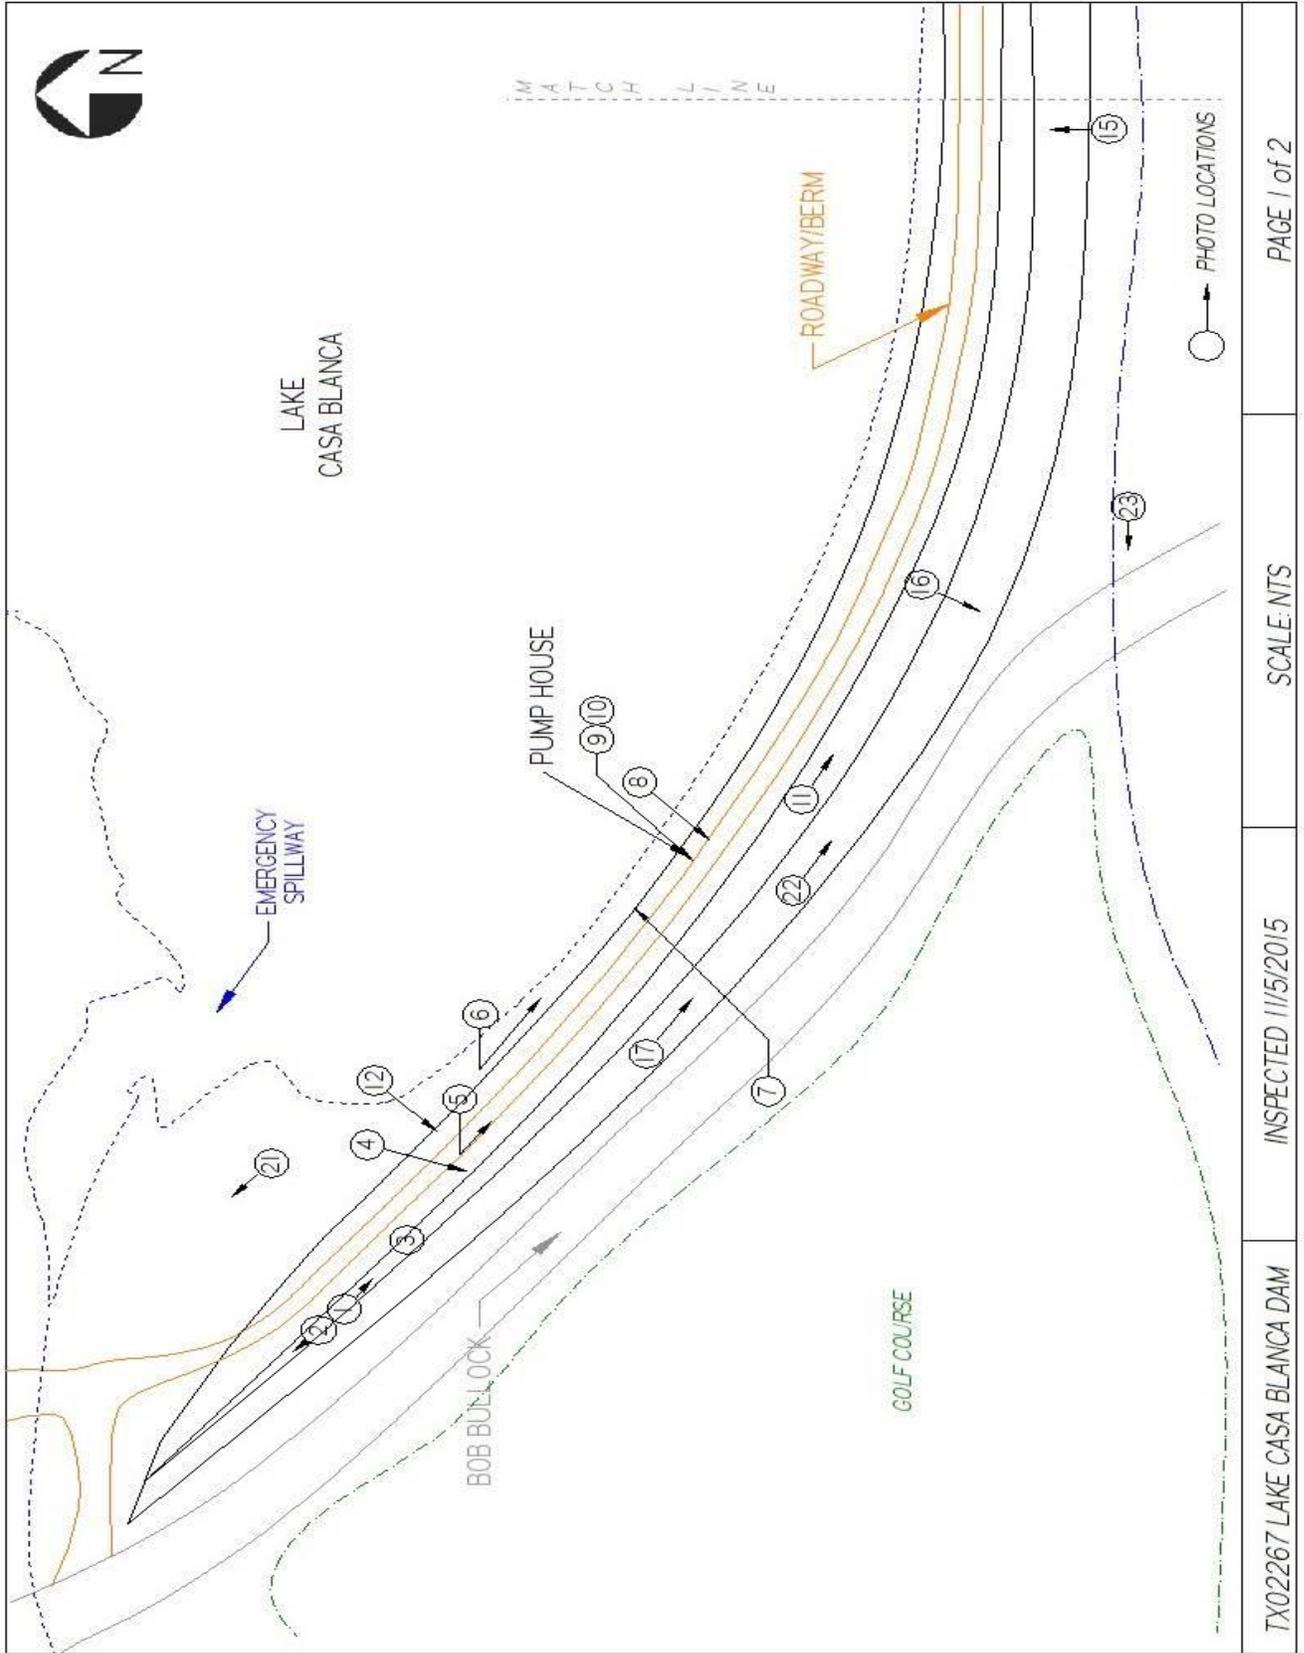
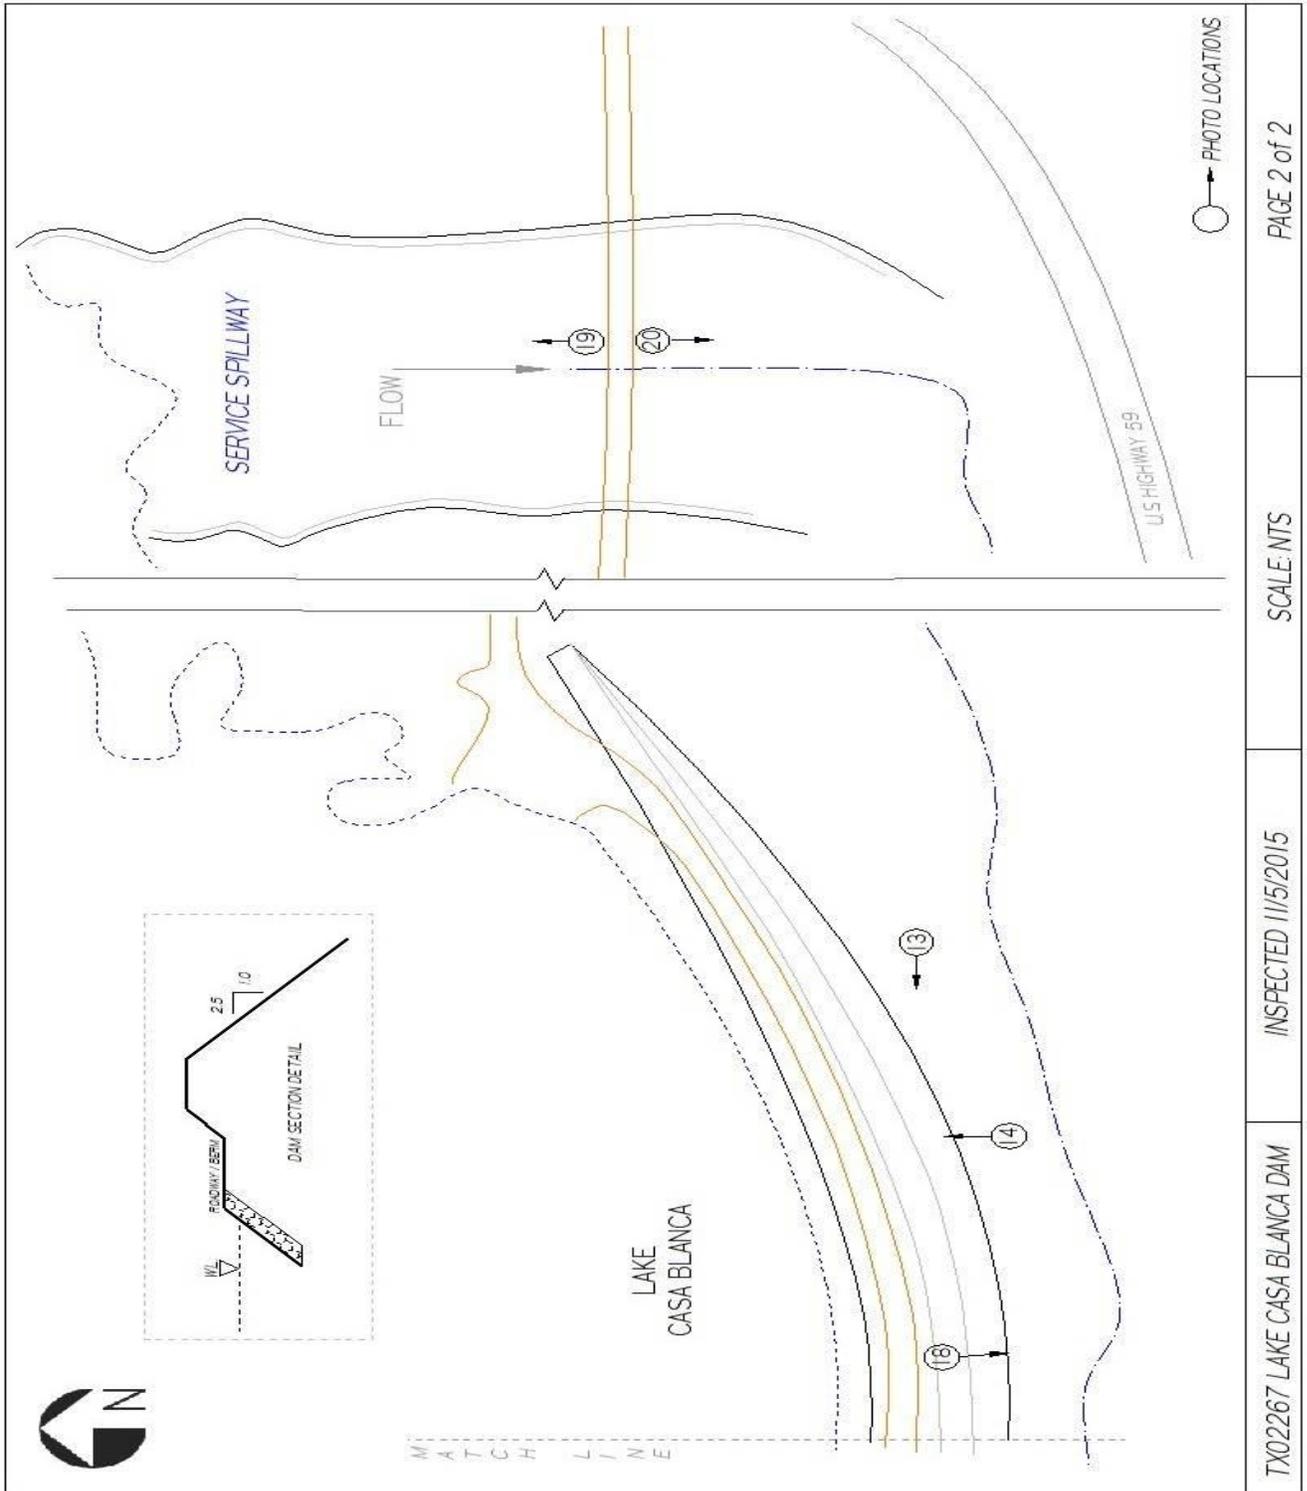
TX02267 LAKE CASA BLANCA DAM	INSPECTED 11/5/2015	SCALE NTS	PAGE 2 of 2
------------------------------	---------------------	-----------	-------------

Figure 1 is a location map. Figure 2 is an aerial photo of the dam with contours. Figures 3 and 4 are sketch maps of the dam and surrounding area, indicating photo locations. Note that right and left indications are from the perspective of an observer looking downstream. Field measurements taken during the inspection were done using a hand-level and survey rod. The water level was measured to be approximately 442 feet-msl.
